Assessment of Ground and Surface Water Impacts: Provincetown Landfill and Septic Disposal Site Provincetown, Massachusetts

Daniel W. Urish, Mary J. O'Reilly, Raymond M. Wright, and
Reinhard K. Frohlich

Technical Report NPS/NARURI/NRTR-93/01

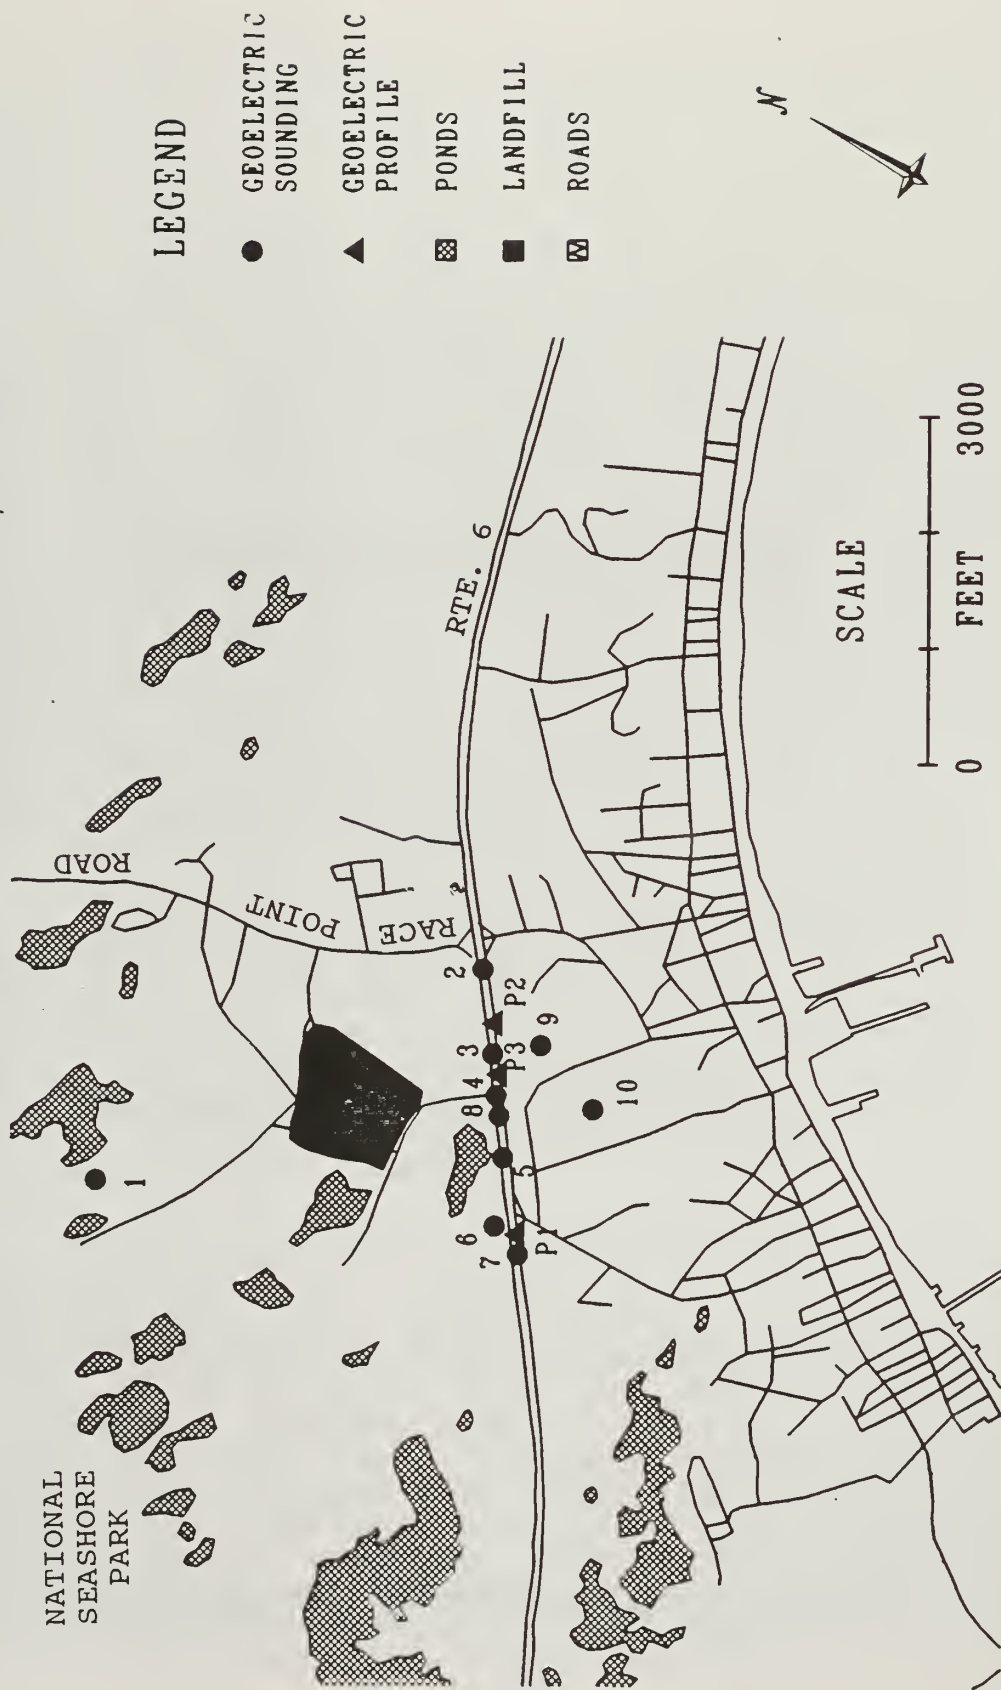
Fig. 2.3. Geoelectrical sounding and profile locations.

Surface geoelectrical surveys were conducted to determine the approximate location of the leachate plume and the depth of freshwater. The majority of this work was performed by Dr. Reinhard K. Frohlich, a Geophysics Professor at the University of Rhode Island. Two different field procedures were used : resistivity sounding and resistivity profiling. In a resistivity sounding the electrode spacing interval is successively increased to measure the change in resistivity with depth. The Schlumberger electrode arrangement is the recommended arrangement for sounding because it is less sensitive to undetected horizontal variations in resistivity and allows a faster field operation since only the current electrodes are moved (Mooney, 1980). In resistivity profiling the electrode spacing is fixed and the electrode array is moved along a transect to determine the resistivity variation in a horizontal direction within a depth range controlled by the electrode spacing. The Wenner electrode arrangement is the preferred arrangement for profiling because there is a wider spacing of the potential electrodes which results in larger potential differences that require less severe demands on precision (Mooney, 1980). The two configurations are represented in Figure 2.2. Symbols A and B refer to the current electrodes through which current is inserted into the ground. Symbols M and N refer to the electrode pair across which the voltage is measured.
